Technical Report 84049

GARTEUR/TP-007

**IMPACT DAMAGE TOLERANCE OF A
CARBON FIBRE COMPOSITE LAMINATE**

G. Dorey
P. Sigety
K. Stellbrink
W. G. J. Hart

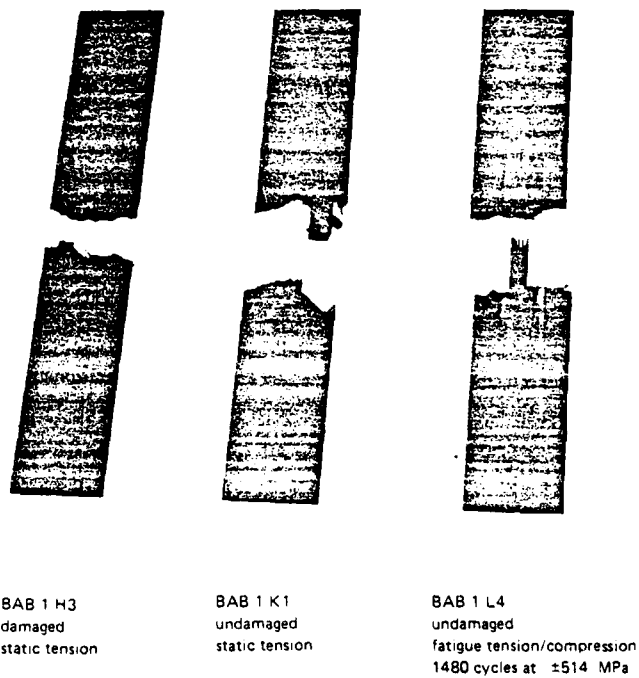
Fig 28 Failed test specimens of $[\text{U } 90 \text{ J } \pm 45 \text{ O}]_s$ carbon fibre laminates (ONERA)

Photographs of fractured specimens are shown in Figs 26 to 31. The static tension specimen shown in Fig 26 (DFVLR) shows evidence of failure from a stress concentration at the end grip; this might explain why DFVLR did not get any static tensile strengths above 630 MPa. Fig 27 shows static tensile specimens for XAS/914 and T300/914; as in the case of C-scans (Fig 6) and fatigue strength (Fig 17) there is evidence of slightly more splitting in the case of XAS/914 even though there was no significant difference in strength. Fig 28 shows ONERA specimens which indicate that fatigue specimens suffer more splitting parallel to the fibres than specimens failed statically in tension. This is also shown for compression specimens, Fig 29. The fracture surfaces found by DFVLR after fatigue testing show that non-impacted specimens had relatively smooth fracture surfaces with much evidence of compression failures (Fig 30) while the impacted specimens showed more splitting and delamination (Fig 31).

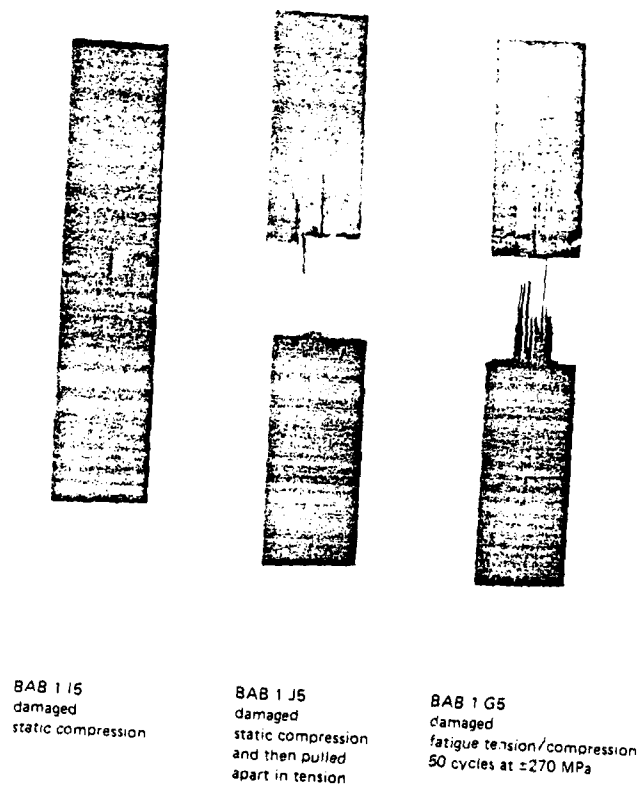
Fig 29 Failed test specimens of $[0\ 90\ 0\ \pm 45\ 0]_s$ carbon fibre laminates (ONERA)

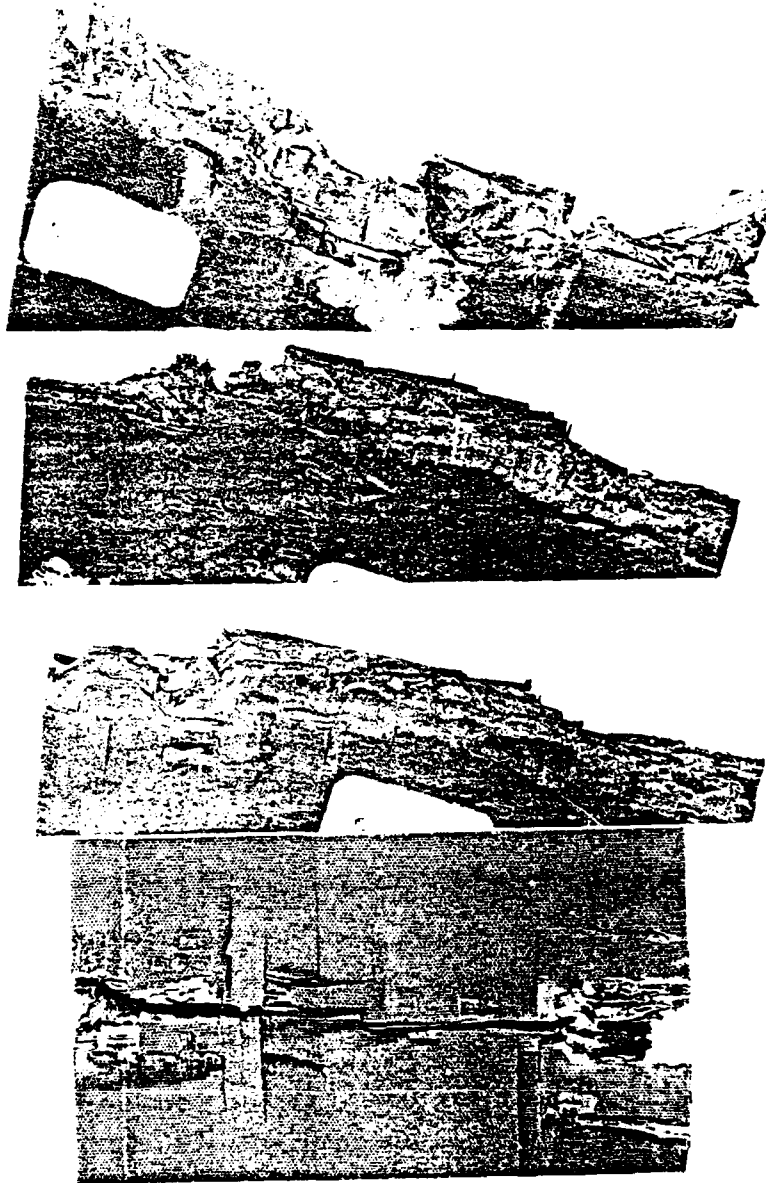
Fig 30 Fracture surfaces from non-impacted $[0\ 90\ 0\ \pm 45\ 0]_s$ carbon fibre laminates tested in tension/compression fatigue (DFVLR)
